Examination of Suspected Delta II Second-Stage Reentry Debris

15 July 2001

P. M. ADAMS and W. H. KAO
Space Materials Laboratory
Laboratory Operations

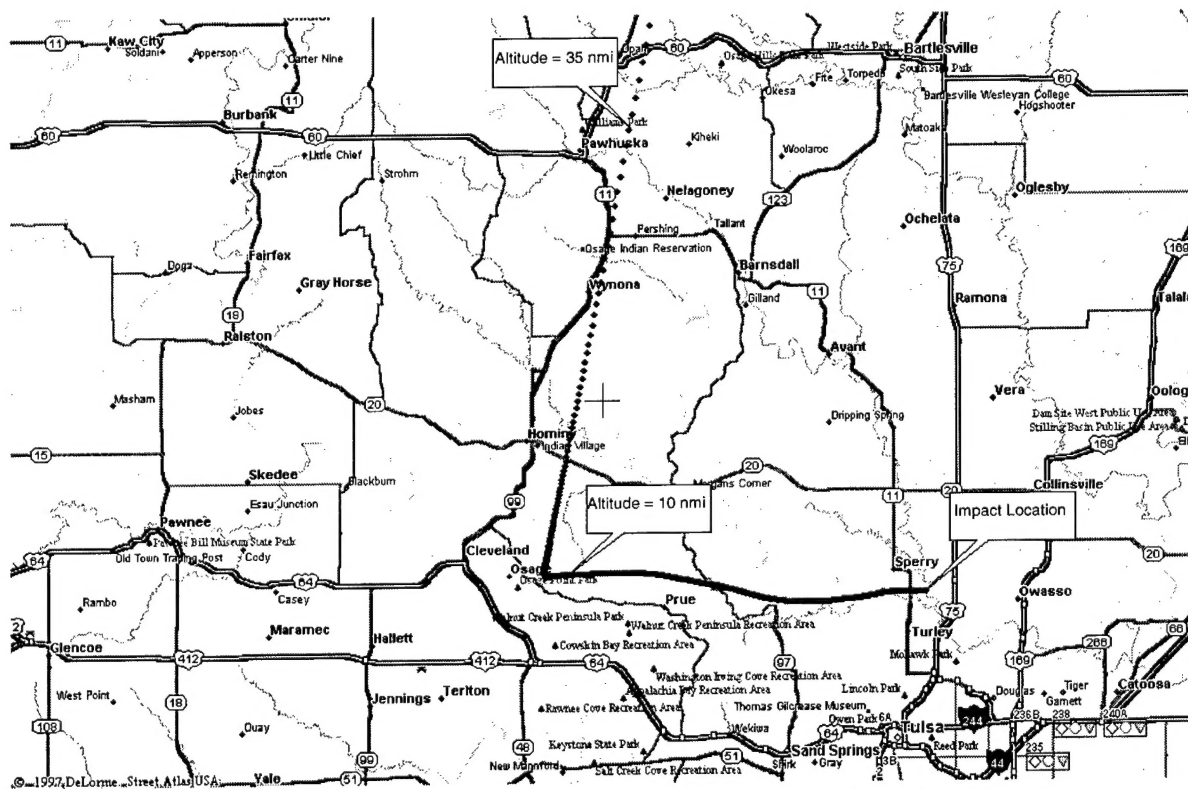
The time and location of the recovery of the debris can be correlated with the reentry of a Delta II second stage. The Delta II was launched from Vandenberg Air Force Base (VAFB) on April 24, 1996, carrying the Ballistic Missile Defense Organization (BMDO) Midcourse Space Experiment satellite. The second stage reentered the atmosphere on January 22, 1997. It was predicted that the vehicle broke up at an altitude of 42 nmi over Topeka, KS at 3:36 AM, local time. The second-stage fuel tank, thrust chamber, and a helium sphere were recovered from several sites in Texas.¹ These areas are about 500 mi. south of Turley, OK, which was along the reentry path. Simulation of the reentry track of a light-weight piece of debris with a low ballistic coefficient, taking into account the presumed breakup altitude, reentry track of the other pieces of the Delta second stage, and the prevailing winds, shows that the debris recovered by Ms. Williams could be from the reentry event (Figure 3).

Figure 3. Simulated reentry track of a light-weight piece of debris with a low ballistic coefficient, taking into account the presumed breakup altitude and reentry track of the other pieces of the Delta II second stage.

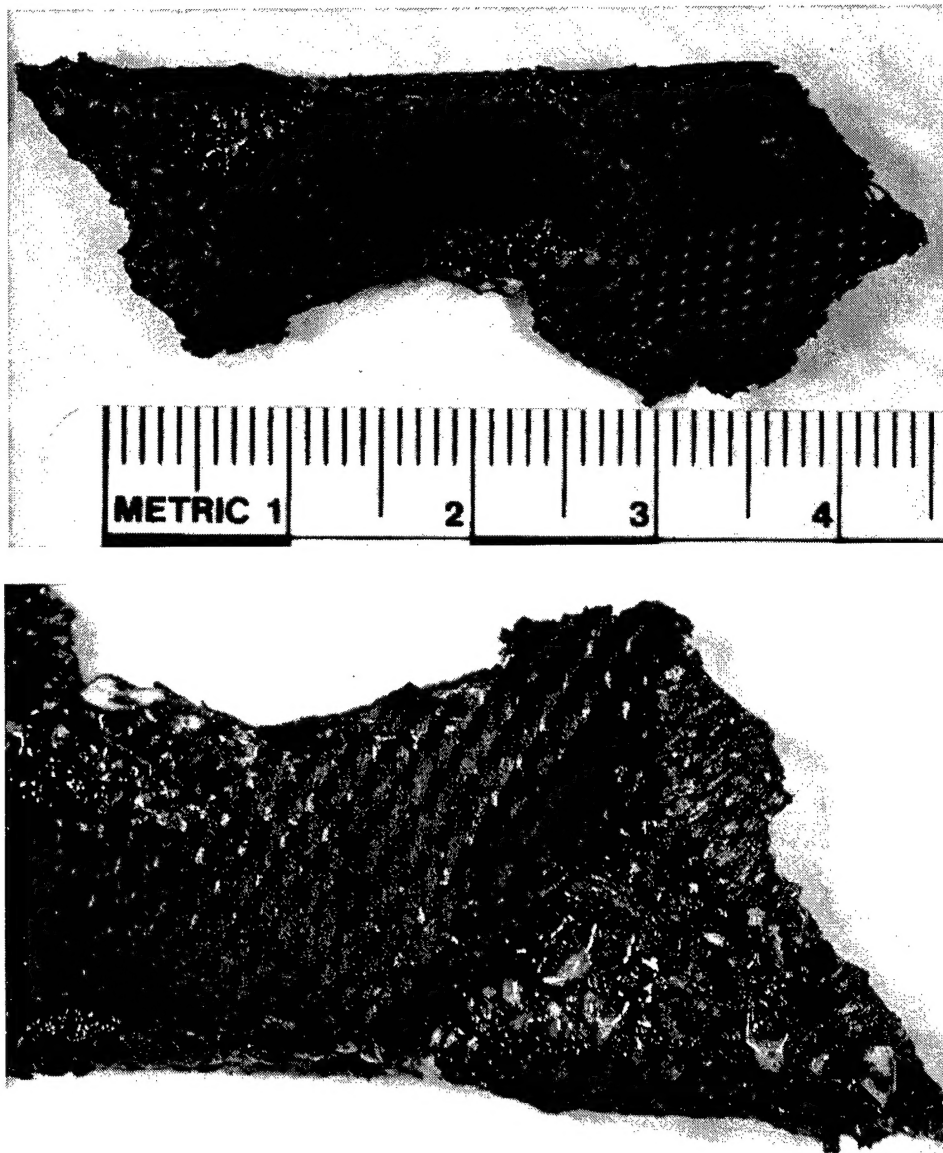
Visually the material appeared to be a piece of black-colored woven fabric that was about 1.5 cm x 0.5 cm x 5.0 cm in size (Figure 4). Initially, before closer inspection and handling, it was thought to be a piece of carbon or graphite fiber cloth because of its color; however, it was very hard and brittle. Upon closer examination, it was found that the fibers were colorless, with a very dark coating, and that there were colorless fused-looking deposits that contained many bubbles (Figure 5). There were also a few small areas (1 mm x 1 mm) that appeared silvery-metallic.

Figure 4. Optical macrophotographs of as-received debris. Upper scale bar is in cm.

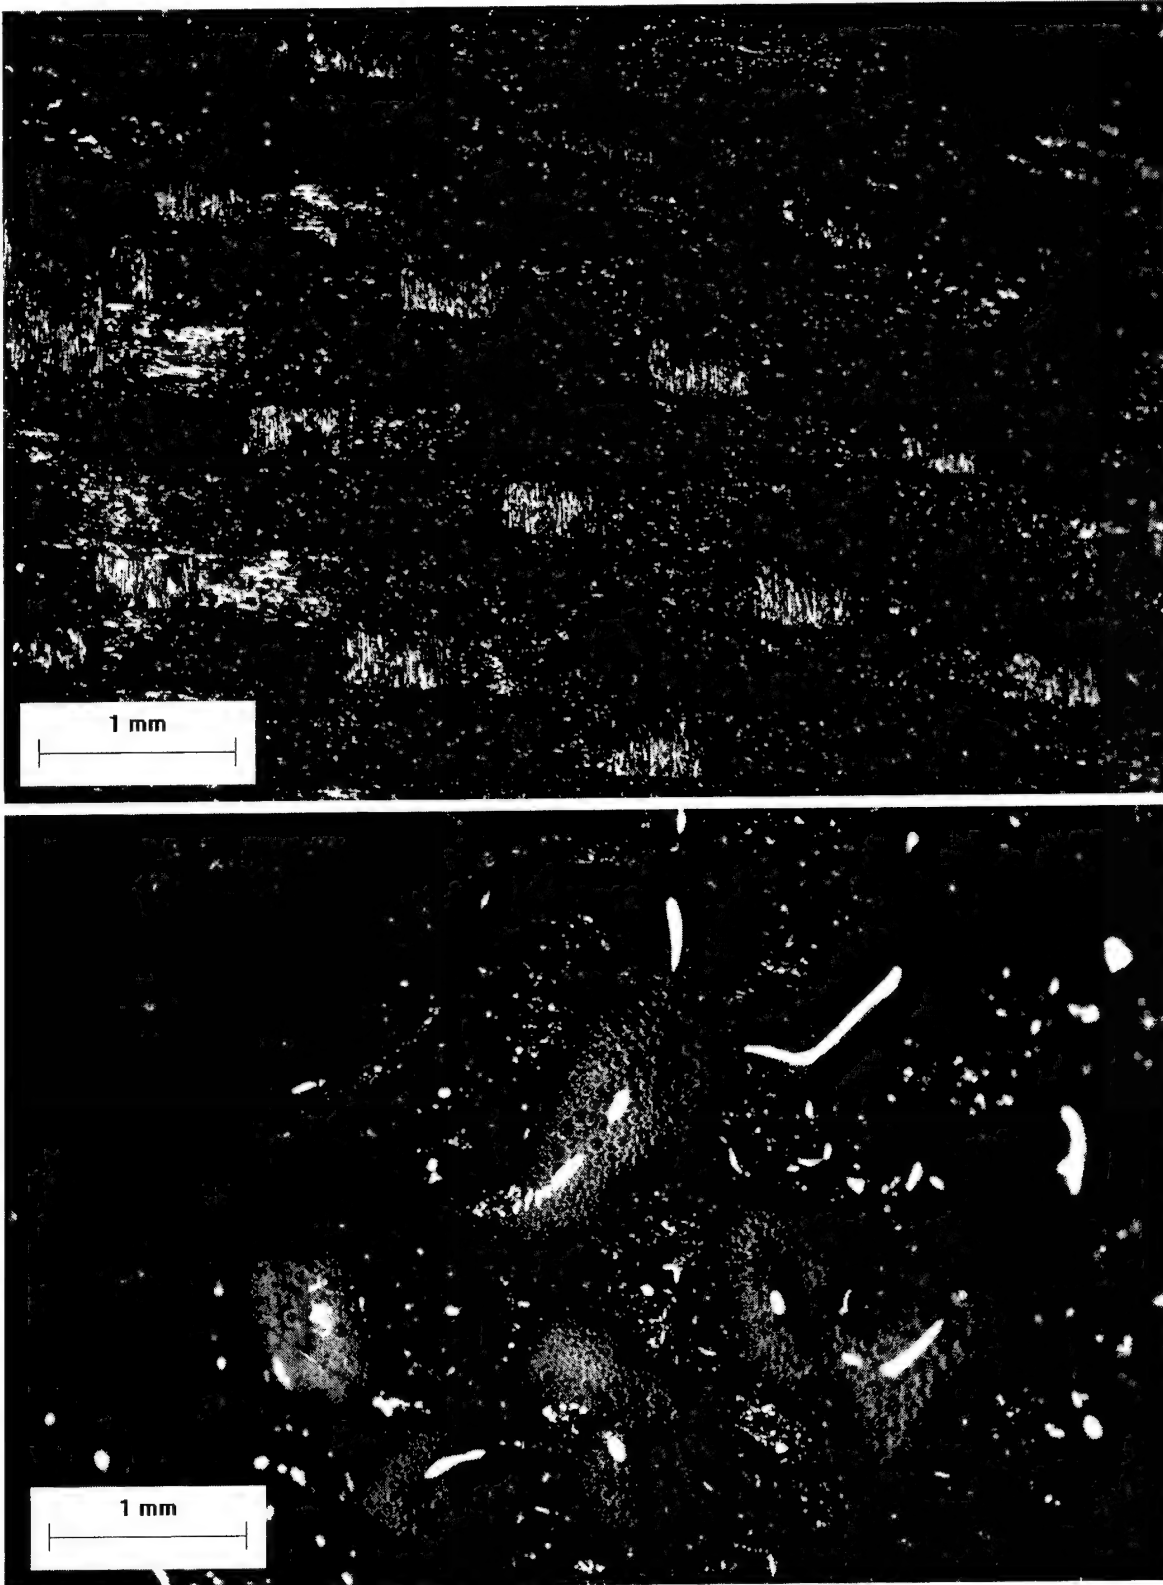
Figure 5. Close-up optical macrophotographs of as-received debris.

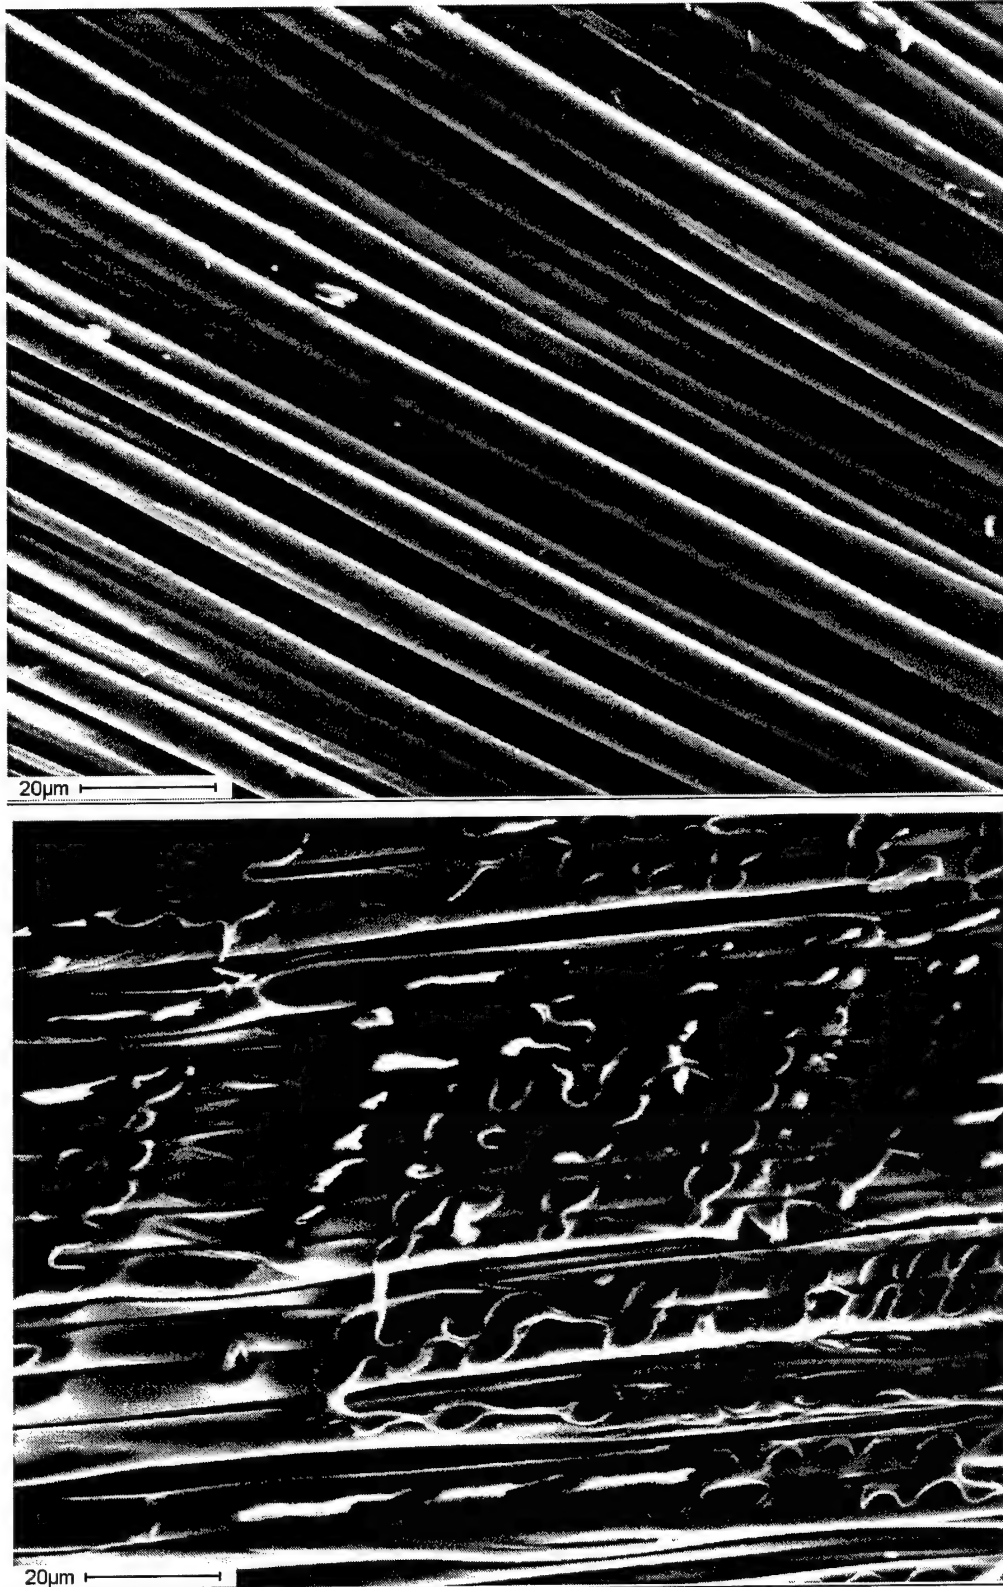
In the SEM, the fibers appeared very smooth, circular in cross section (about 9 μm in diameter), and locally covered with thin deposits (Figure 6). The fused-looking areas had smooth surfaces, and in some areas bubbles were observed on fracture surfaces (Figure 7). The chemical analyses of the fibers and fused deposits indicated that they both contained primarily oxygen (O), silicon (Si), calcium (Ca) and aluminum (Al) (Figure 8), which is consistent with the material being fiberglass. It is noted that the EDXS system can not detect lithium or boron. The residue on the fibers (lower photograph in Figure 6) consisted primarily of carbon (C) (Figure 8). The metallic-looking areas had a number of different textures, which ranged from rounded-melted, to folded, to feathery-dendritic (Figures 9 and 10), which probably resulted from the melting and resolidification of the aluminum. Several of the small silvery-metallic deposits were analyzed by EDXS, and all contained primarily aluminum (Al) and oxygen in varying proportions (Figure 11); however, minor amounts of magnesium were occasionally detected. The lower picture in Figure 10 shows the dross layer, which consists of aluminum oxides and impurities, that forms on the surface of molten aluminum that is in contact with an oxidizing atmosphere for a certain length of time. The EDX spectrum from this area did show more oxygen (bottom of Figure 11) than in other metallic areas. The depth of penetration in the EDX analysis is on the order of 1 μm . An XRD pattern of one metallic particle indicated that the bulk of the material was metallic aluminum; however, some very weak lines attributed to alpha aluminum oxide ($\alpha\text{-Al}_2\text{O}_3$) were also observed. Based on the XRD and EDX analyses, it is assumed that the aluminum oxide is a thin surface layer.

Figure 6. SEM photographs of fibers in the debris.

The chemical composition of the fibers is consistent with their being a type of fiberglass. There are several types of glass fibers, at least one of which (E-glass) has a composition (calcium aluminoborosilicate) consistent with the analyses of the debris (boron can not be detected by EDXS). The fact that the compositions of the fibers and fused deposits were nearly identical implies that the fused material was derived from melting of some of the fibers.

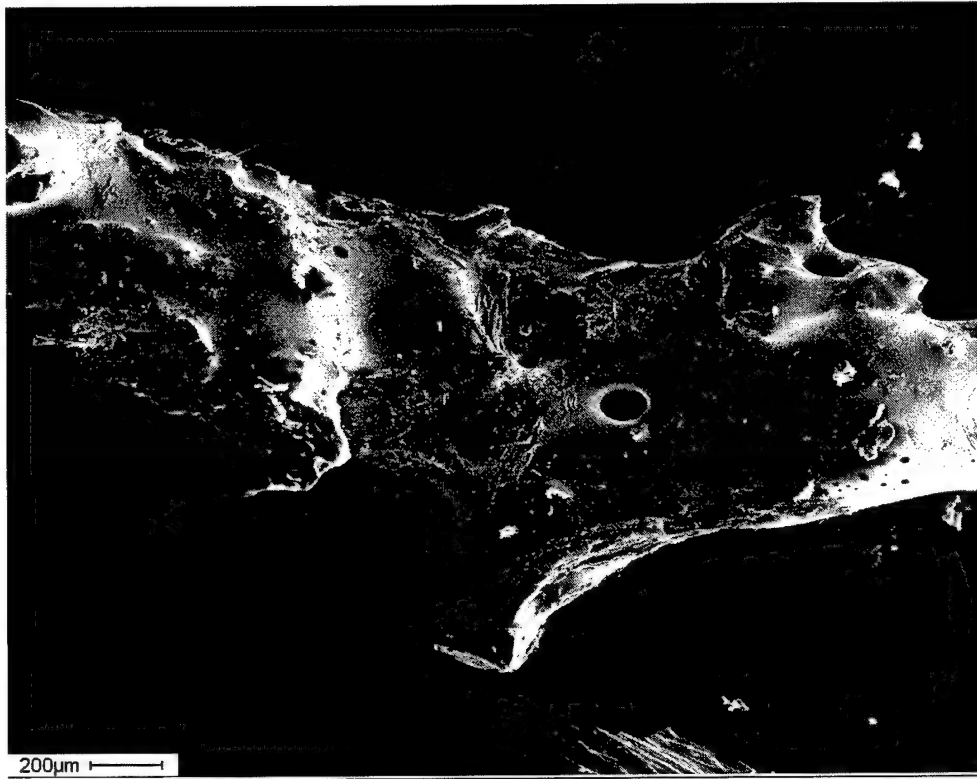
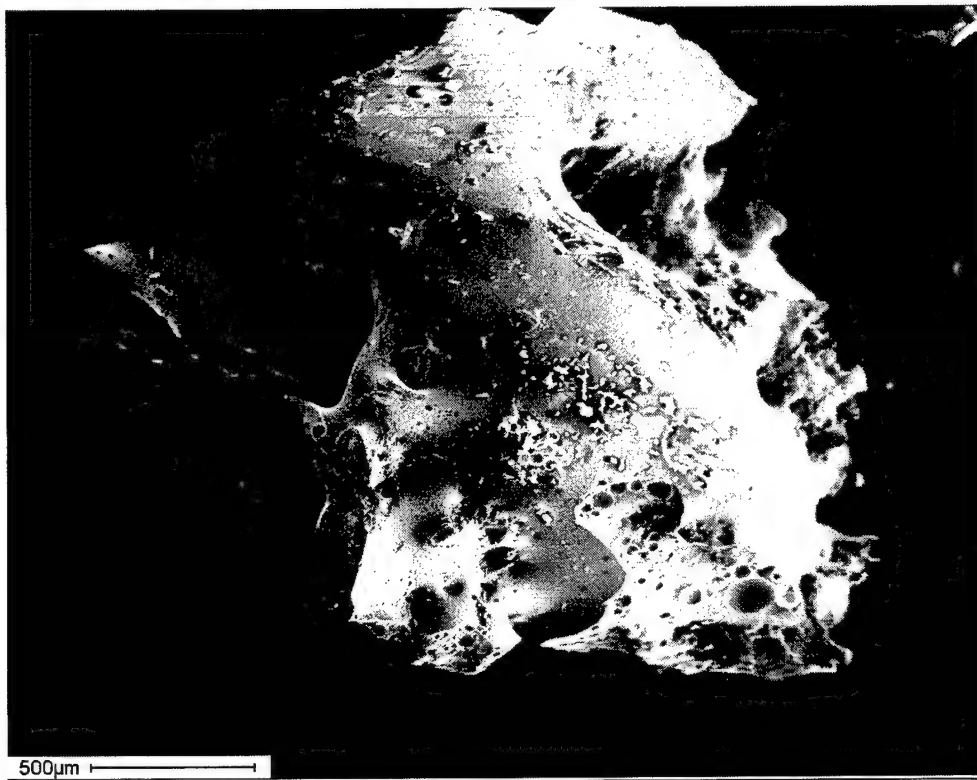
Figure 7. SEM photographs of fused deposits on debris.

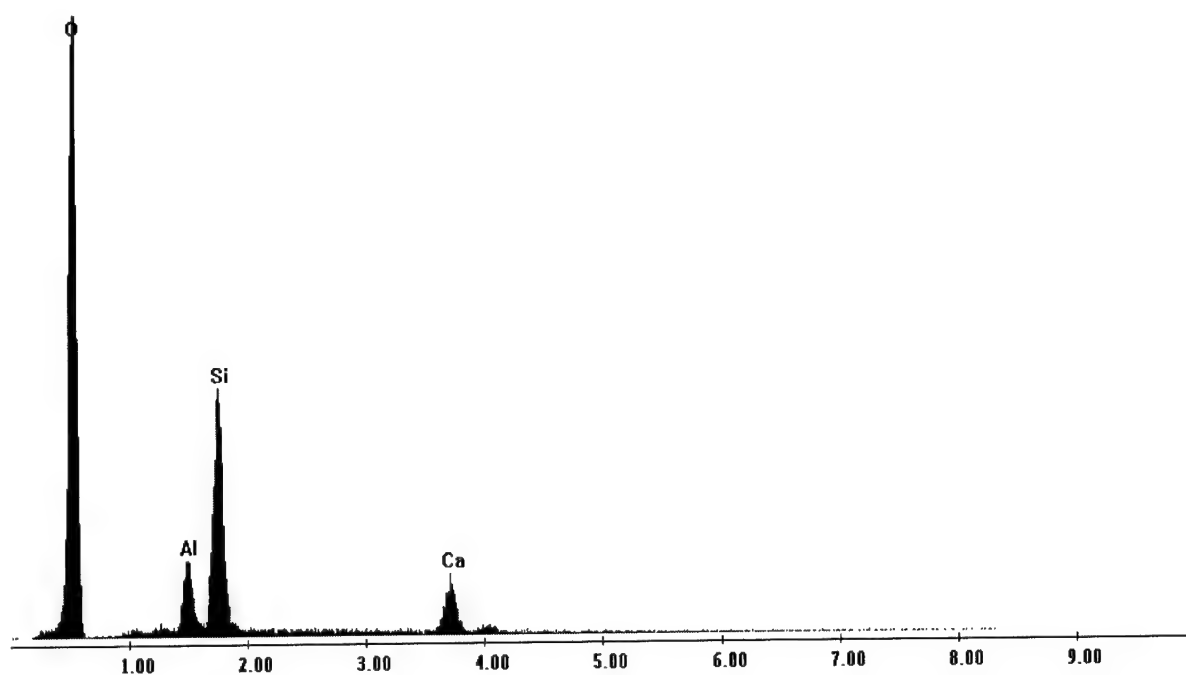
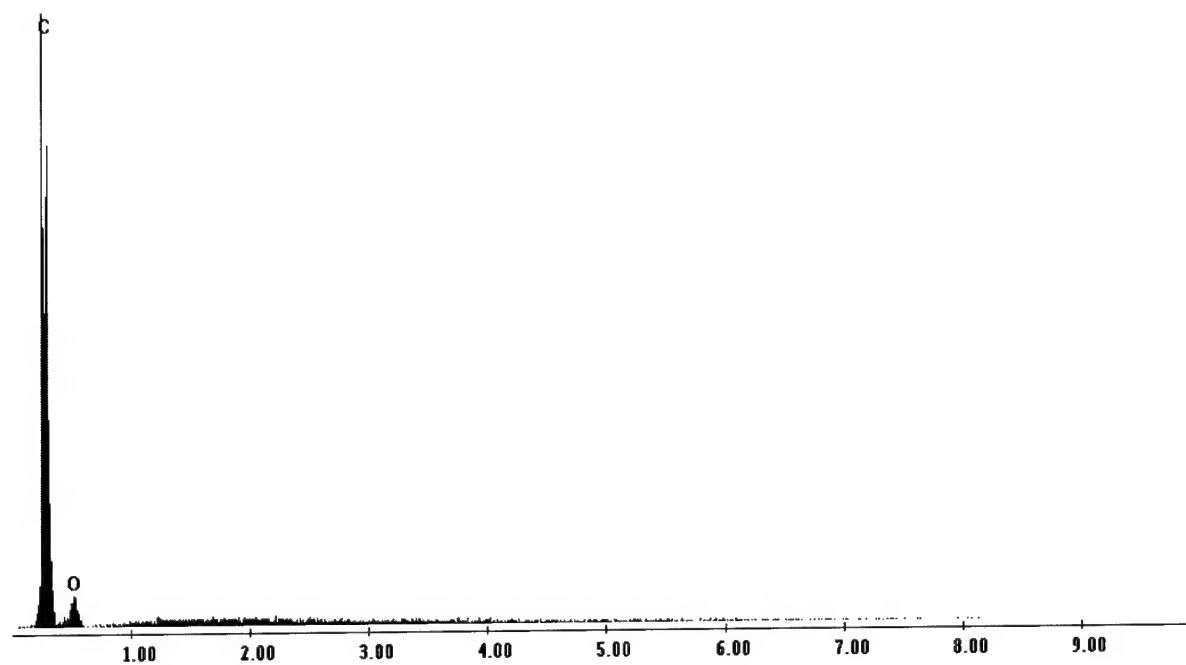
Figure 8. EDX spectra of fibers in debris (top) and deposit on fiber (bottom).

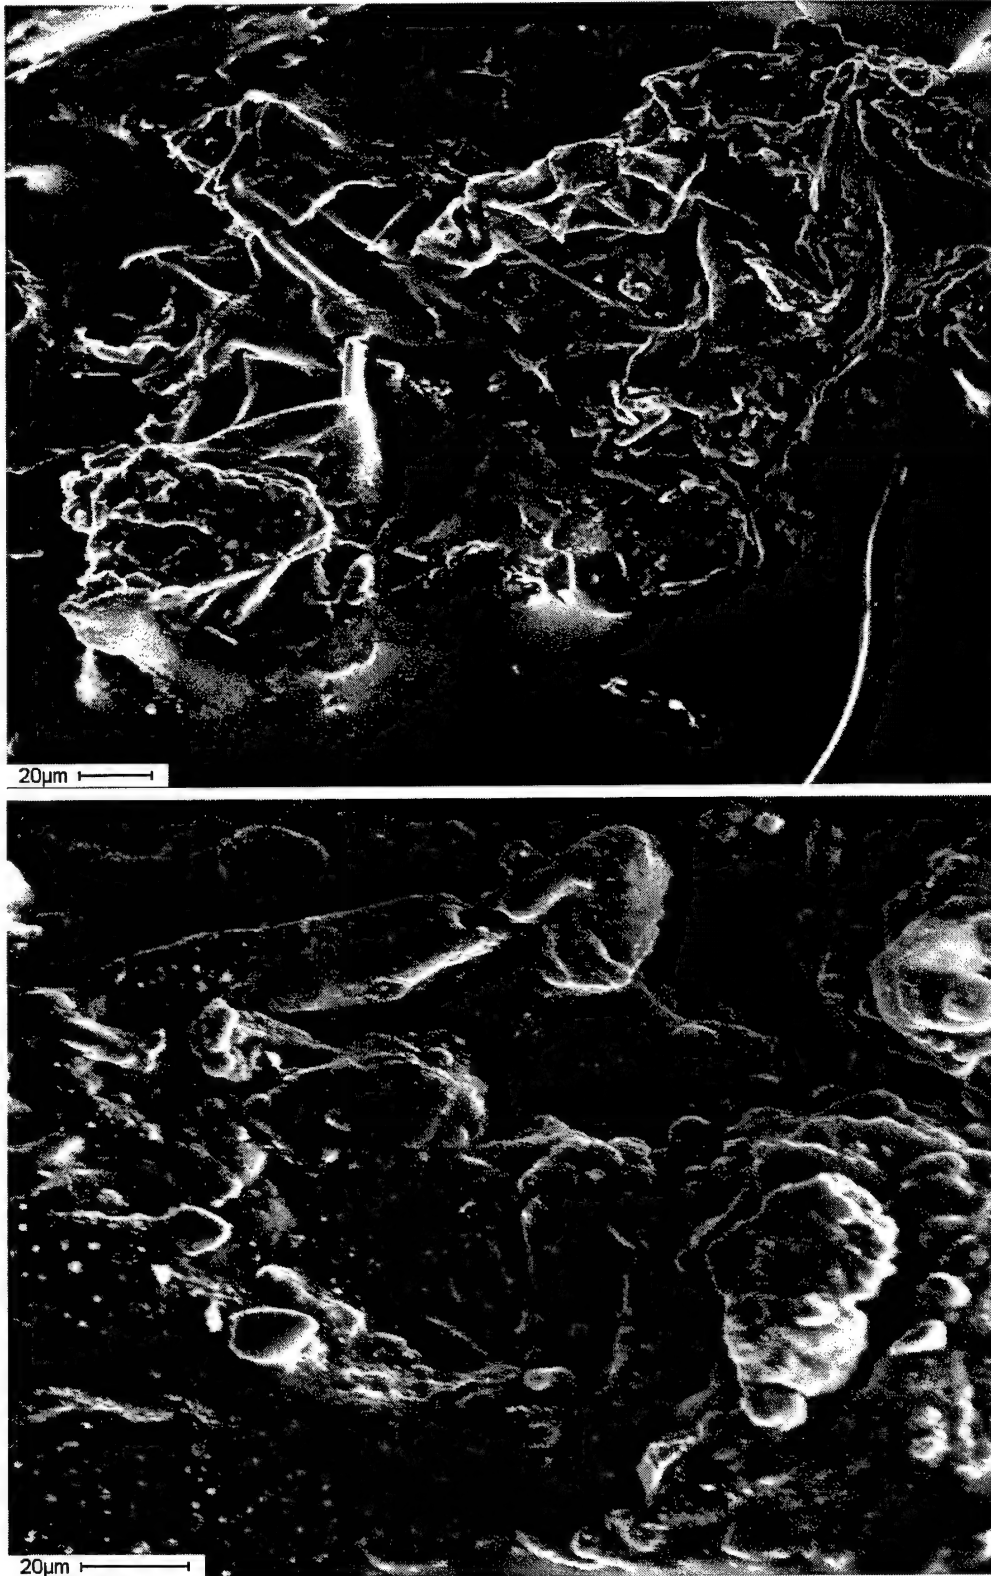
Figure 9. SEM photographs of metallic deposits on debris.

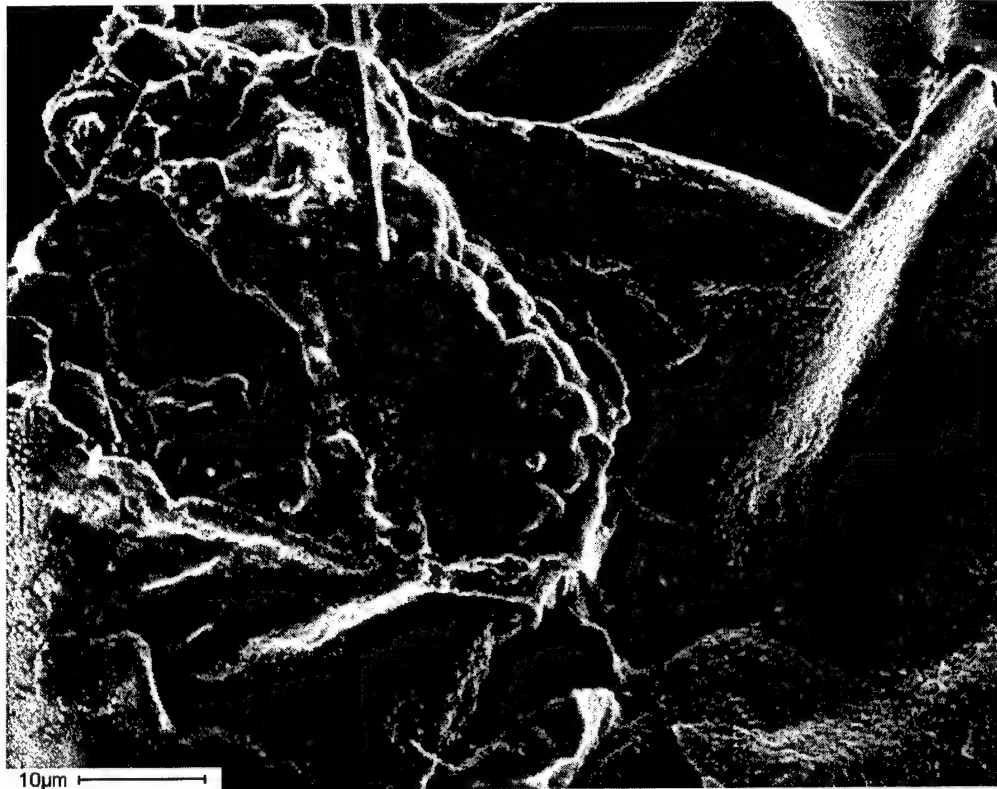
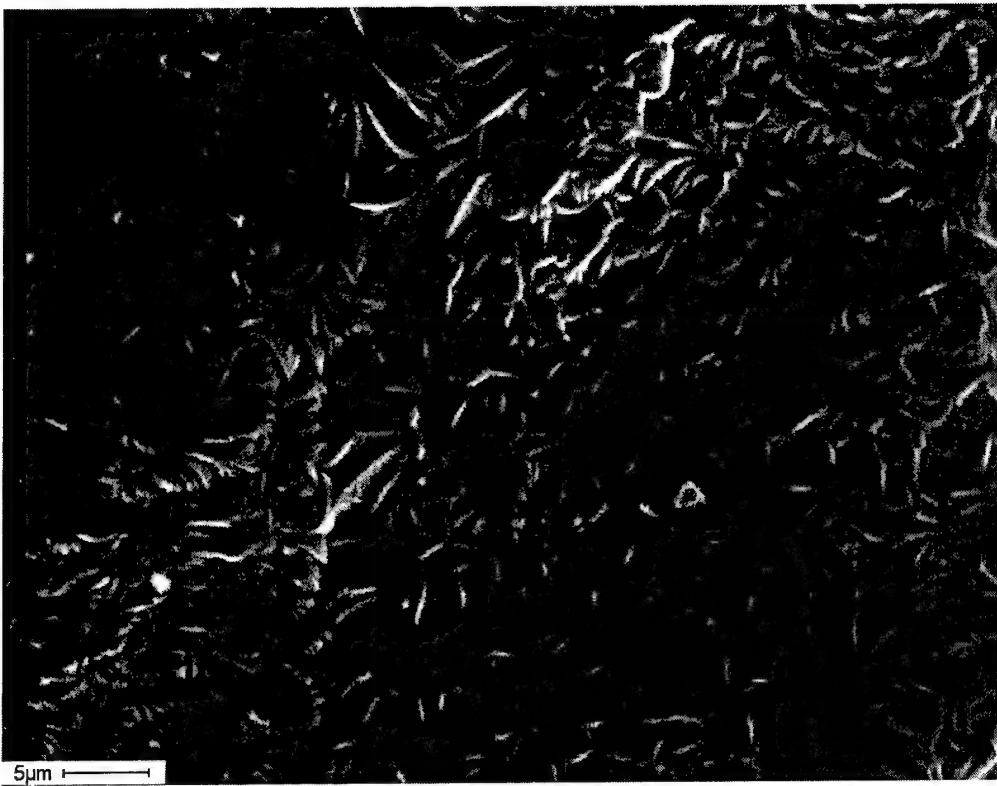
Figure 10. SEM photographs of metallic deposits on debris.

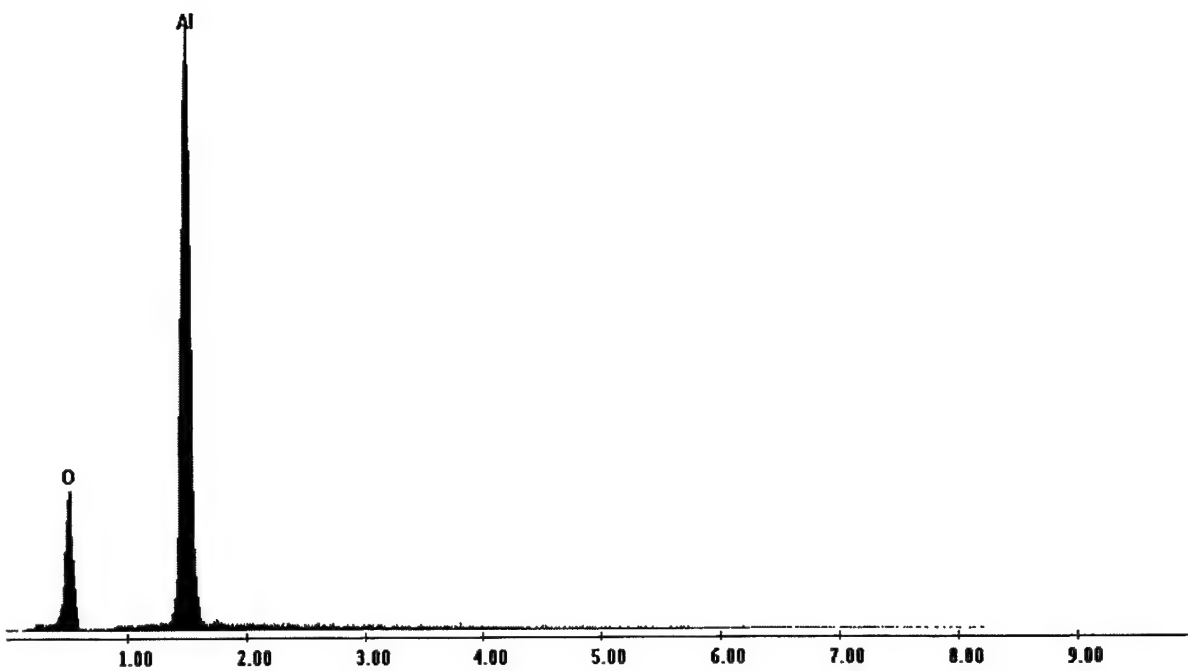
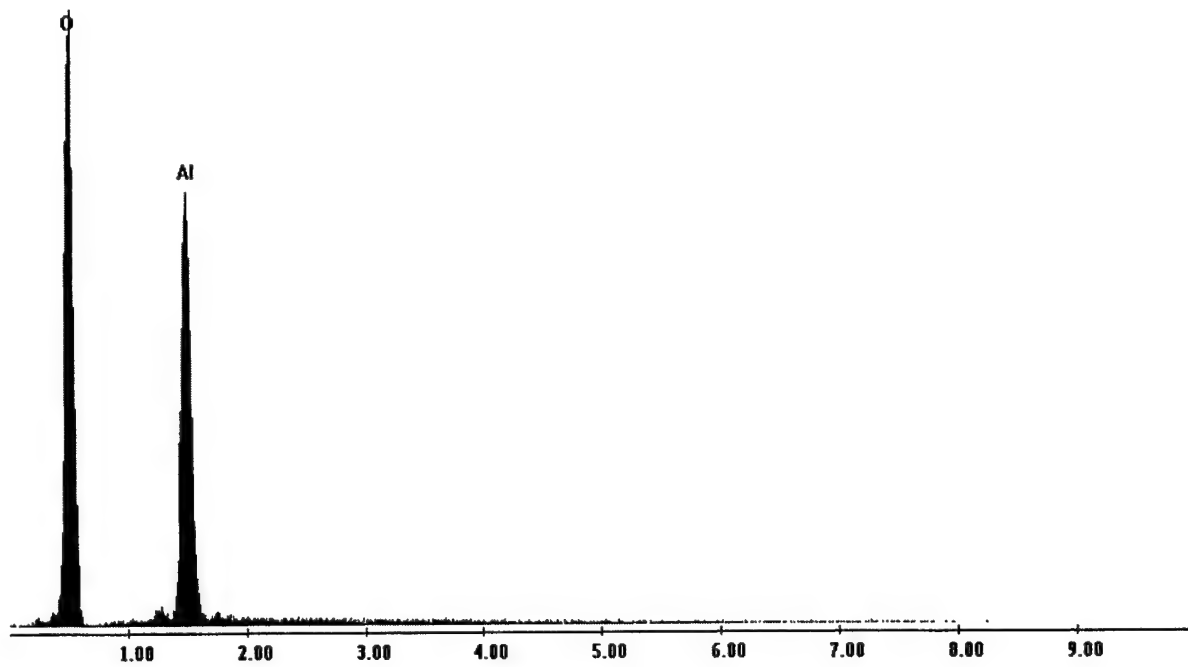
Figure 11. EDX spectra of shiny metallic deposits in debris.

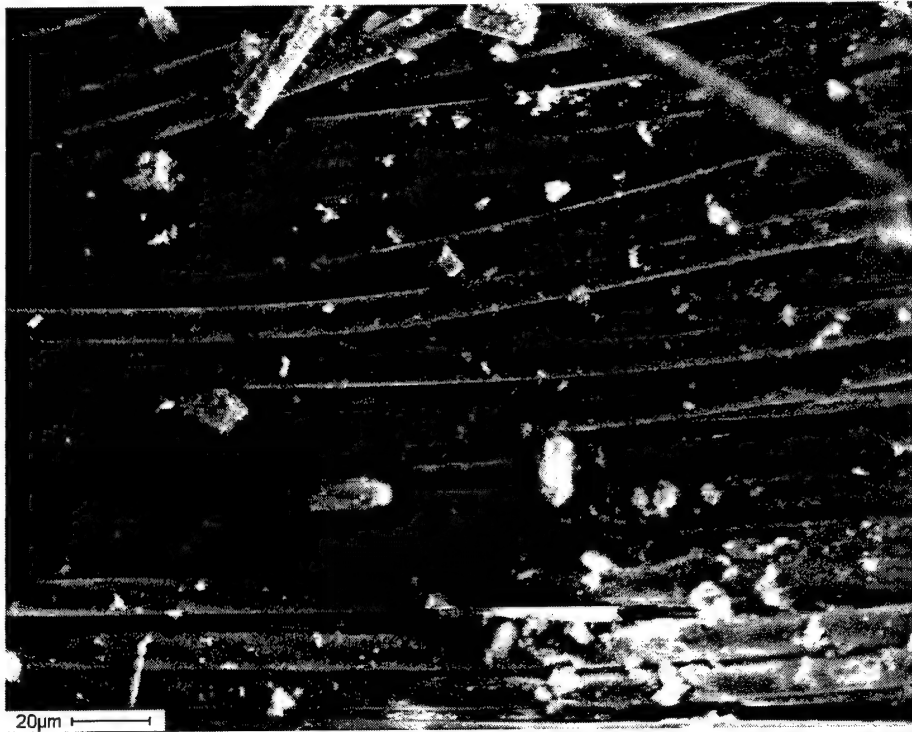
Figures 12 and 13 are SEM photographs of the glass fibers from the silica phenolic and glass fabric overwrap, respectively. The fibers from both materials are similar in size and appearance with the fibers from the debris. Figures 14 and 15 present the EDX spectra of the glass fibers from the silica phenolic and glass fabric overwrap, respectively. It can be seen that the fibers from the silica phenolic contain only silicon and oxygen, indicating that they were not the source of the debris. However, the spectrum of the overwrap fibers contains oxygen, silicon, calcium, and aluminum, and is nearly identical to that of the debris fibers (Figure 8). Figure 16 compares the debris with the fabric from the overwrap. The weave pattern in each is very similar.

Figure 12. SEM photograph of fibers from silica phenolic liner of test fired thrust chamber.

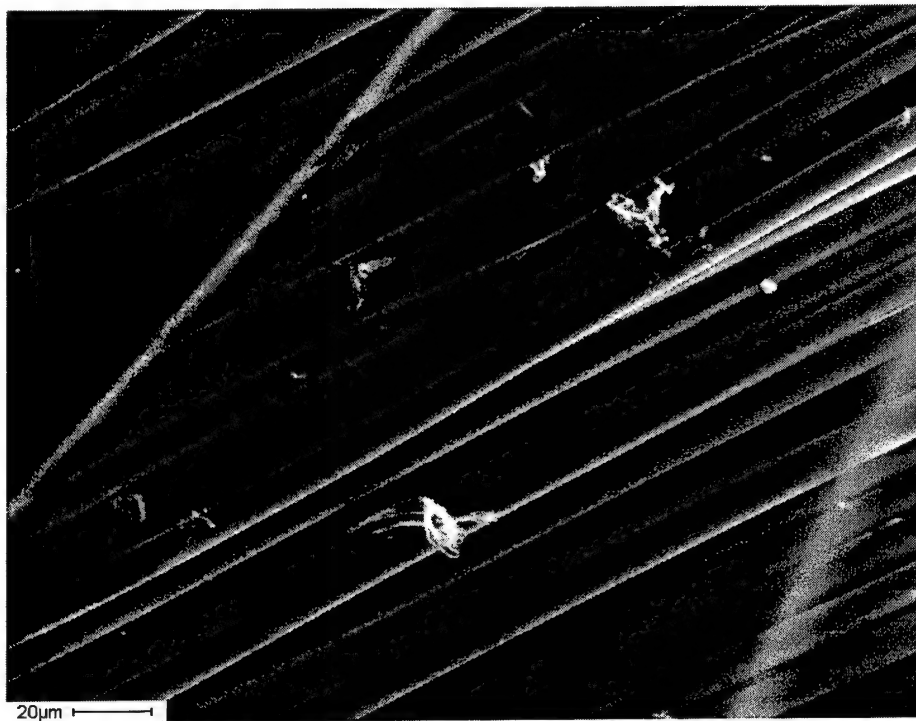
Figure 13. SEM photograph of fibers from glass fabric overwrap used on thrust chamber.

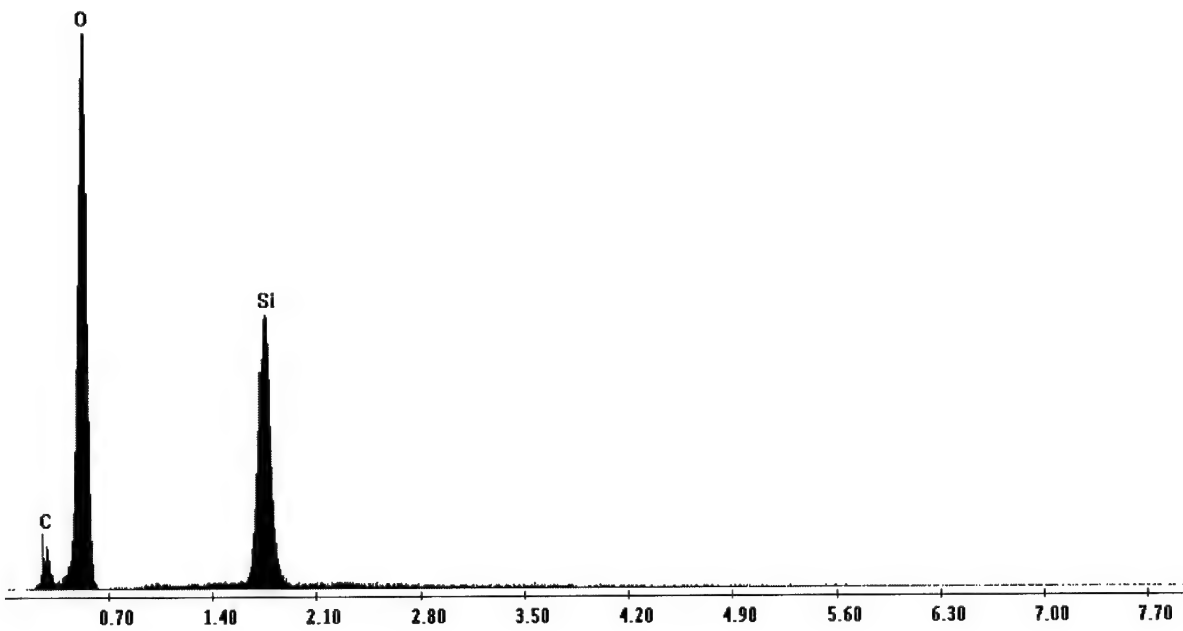
Figure 14. EDX spectrum of fibers from silica phenolic liner.

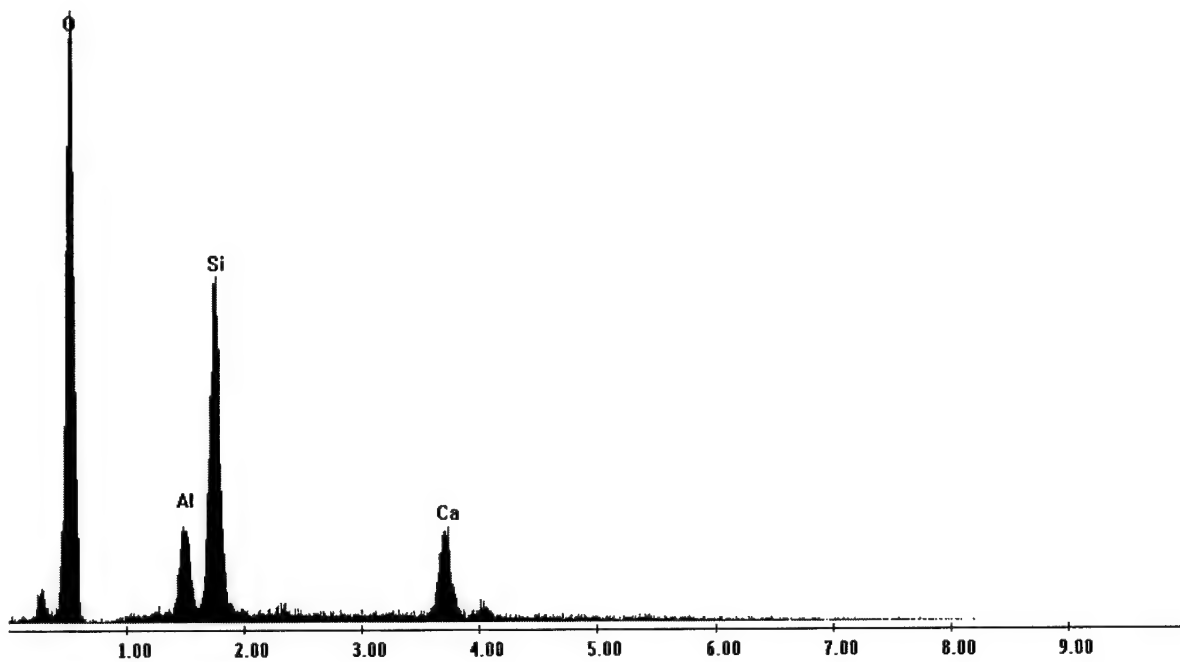
Figure 15. EDX spectrum of fibers from thrust chamber glass fabric overwrap.

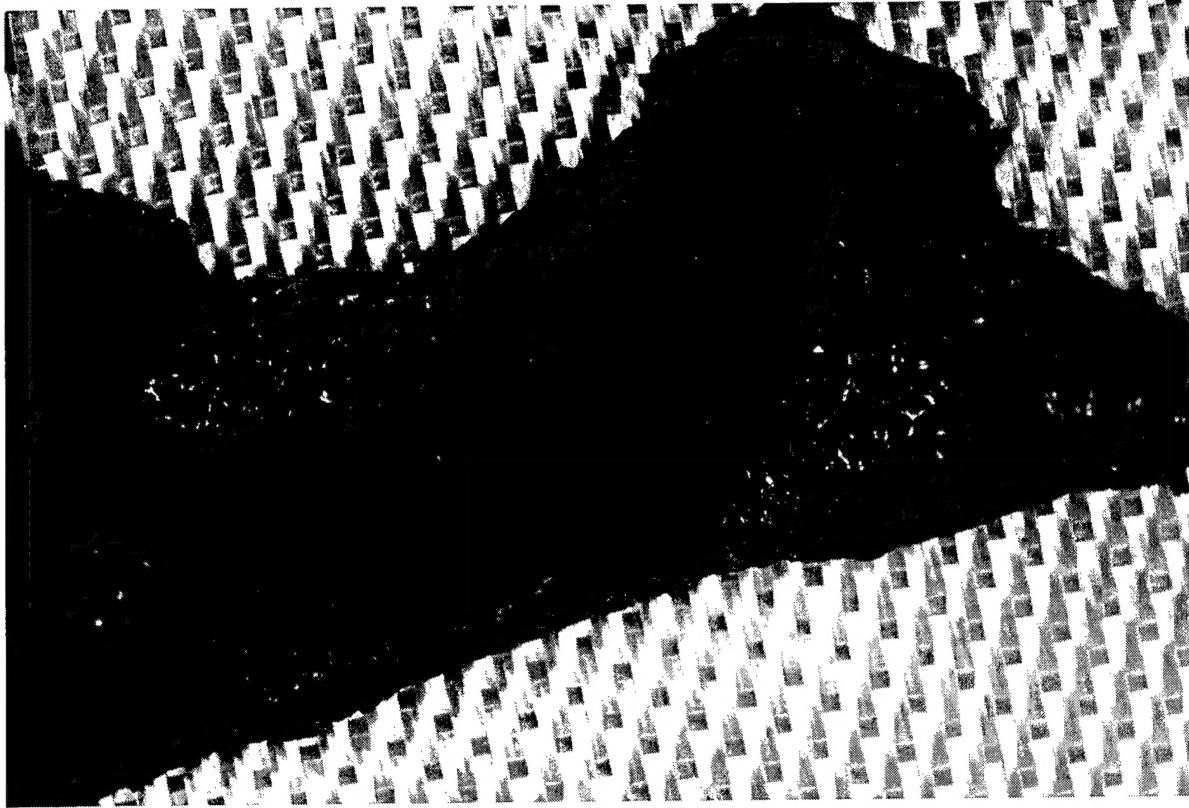
Figure 16. Optical photograph comparing weave pattern in debris with glass overwrap fabric.
